Studying Damaged Moment Beams Reinforced With Carbon Polymer

Abstract

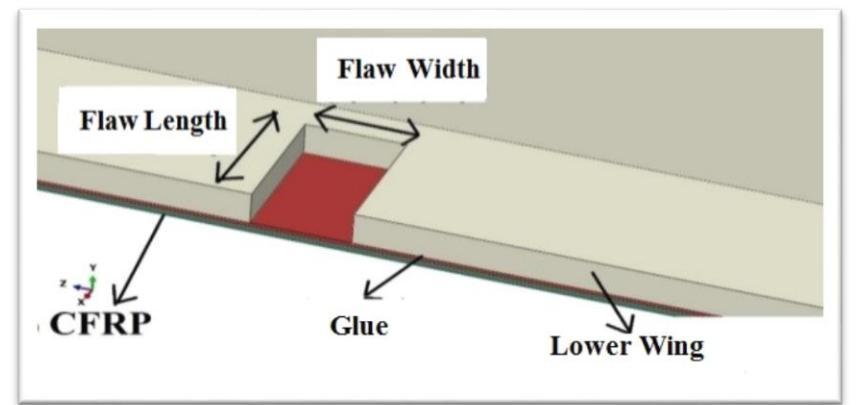
In this paper, different sizes of defect points were used. At first, for reaching an appropriate length of CFRP, defect with $20 \times 30 \text{ Mm}^2$ was used in which, the first number is the length of defect and the second one is the width of defect according to the below figure (1).

The defect with bilaterally dimensions of $(20\times30\text{mm})$ with CFRP with a medium modulus of (2400 GPa), thickness of (1/4mm) and different lengths of (1000,700,500,400 and 300mm) are investigated for obtaining appropriate length that finally, length of 400mm is chosen as an appropriate length. It should be noted that in samples, the first number is the length and the second one is the width of defect (figure 1).

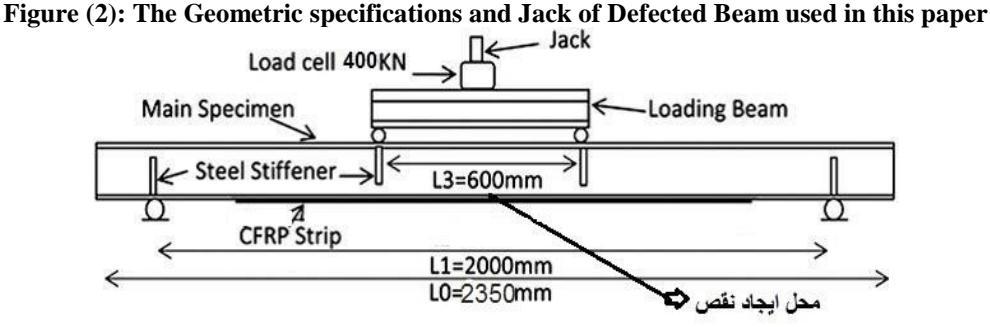
Steel beam of IPE160 with 2350 mm length, final resistance of 370 MPa and final strain of 13.5% was modeled as nonlinear. Geometrical figure of the beam is shown in figure (2). Table (1) proposes specifications of the steel beam.

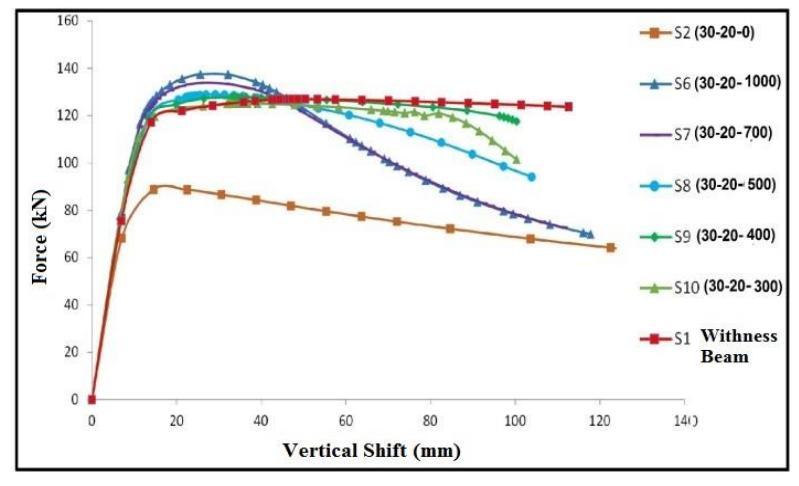
Figure (3): Vertical displacement in the mid span for the defect beam $(20 \times 30 Mm^2)$

For reaching an appropriate length of CFRP sheet, defect dimensions of $(20\times30\text{mm})$ with CFRP strip and medium modulus of (2400GPa), thickness of (1/4mm) and different lengths of (1000,700,500,400 and 300mm) were modeled. Figure (3) shows that created defect in defectless beam causes decreasing in loadcapacity by 30%. For restoration and reaching load capacity of defectless beam which is the control beam, lengths of 1000,700,500,400 and 300 mm from CFRP strips with 1/4 thickness were used that increasing of 37%, 34%,32%,30 and 28% were obtained respectively. It can be inferred that 400mm length is the best selection for repairing defect as it can have performance such as defectless beam and it is also recommended for sample beams with greater defect. Also in figure (4), fracture mode of reinforced beam sample is shown in defect area that strain focus on adhesive, end-debonding phenomenon at the end of CFRP sheet and tension focus in defect area are observed.

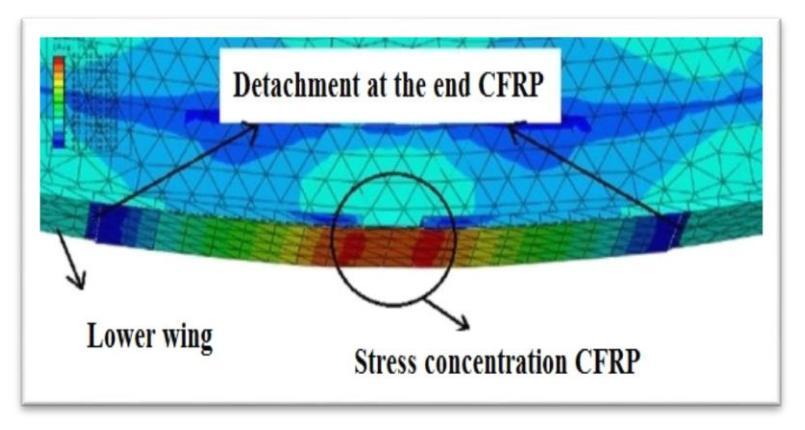
Figure (10): strain focus on adhesive, end-deboning phenomenon at the end of CFRP sheet and tension focus in defect area

- Local debonding in CFRP sheets resulted from defect, causes a sudden increase in adhesive tension, and respectively, CFRP slips. With increasing load amount, the strain of CFRP sheet in defect area and debonding strain is considerable.
